Manhole Inspection Summary

Manhole # S33EE1015MH

Insp Date: **4/28/07 10:49 AM**

Location Address: **3800 CHARLES ST**

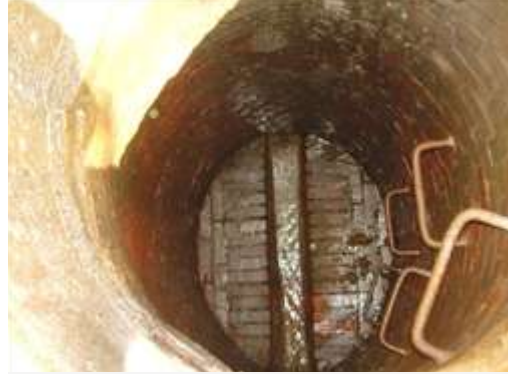
Top View

Evidence of surcharge - Bench debris.

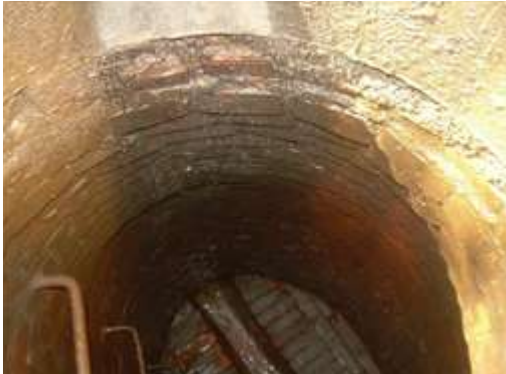
Defect

Frame leaks. Adjustment deterioration and infiltration. Corbel and Barrel infiltration - other side.

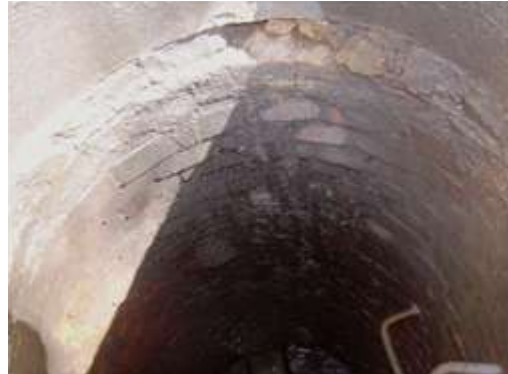
Defect

Frame leaks. Adjustment deterioration, loose brick and infiltration. Corbel and Barrel infiltration.

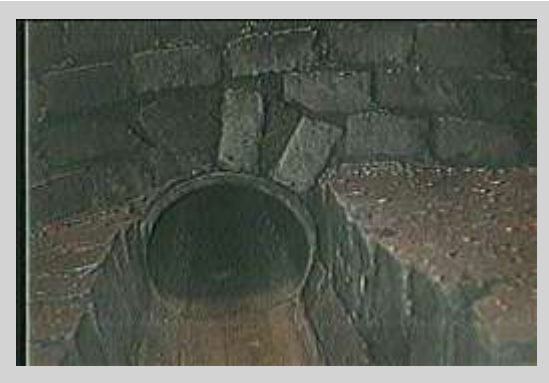
8 in. Circular Gravity Sewer Pipe Out @ 12 O'Clock

Barrel deterioration and infiltration. Channel deterioration.

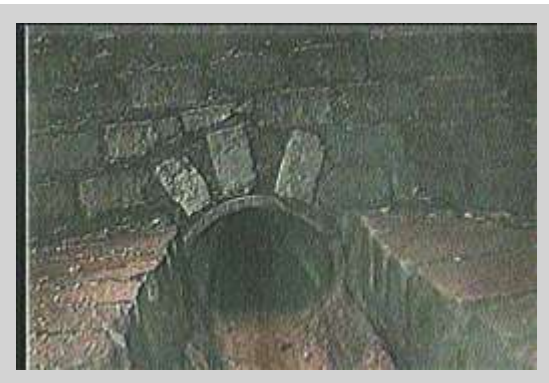
8 in. Circular Gravity Sewer Pipe In @ 6 O'Clock

Barrel deterioration and infiltration. Channel deterioration.

Infiltration: **Evidence** Pipe Seal Cond: **Unknown**
